Emergency: Rotor discs replaced

Quick repairs keep 16T tests on track

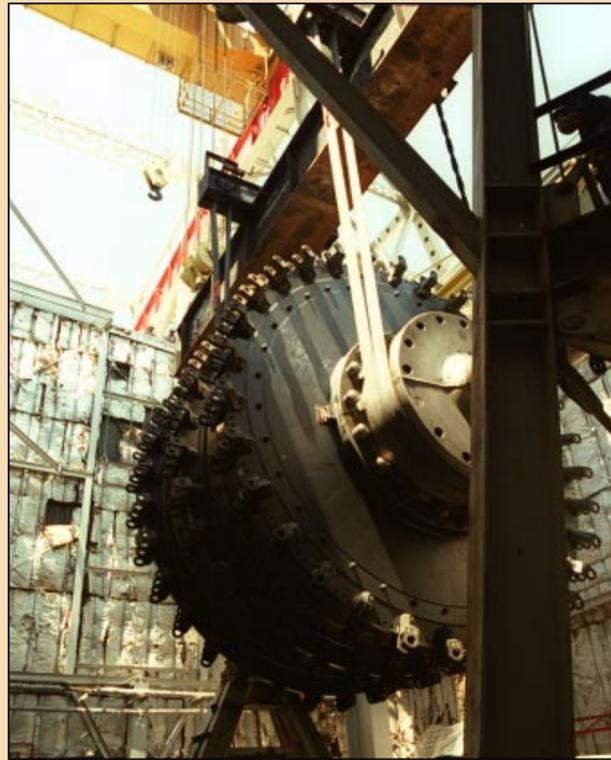
Iron workers use crane to lift C1 rotor to compressor.

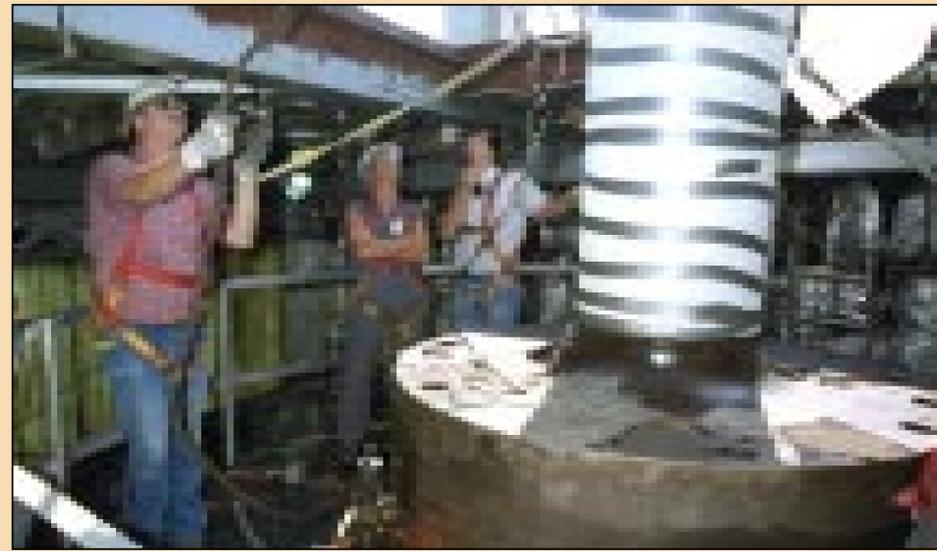
Wayne Brown (front left), Roy Jones, Brian Bergmann and Joe Sanders set the C1 rotor into bearings.

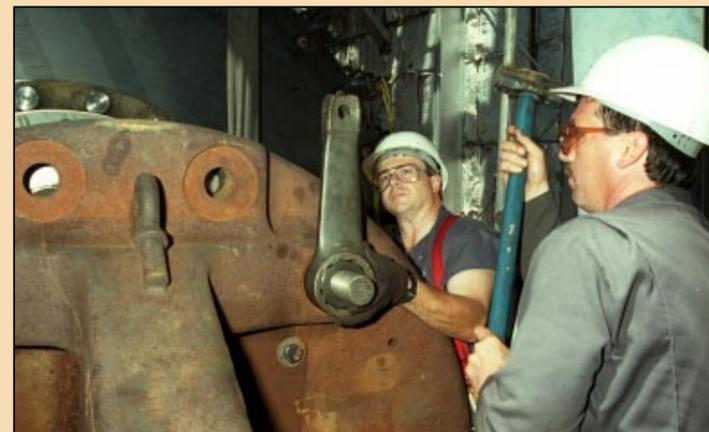
Outside machinists, Tommy Bush (left) and Brian Bergmann, remove the bolt fastening the C1 rotor to the turning trunion in the rotor erection frame before lifting the rotor from the stacking building.

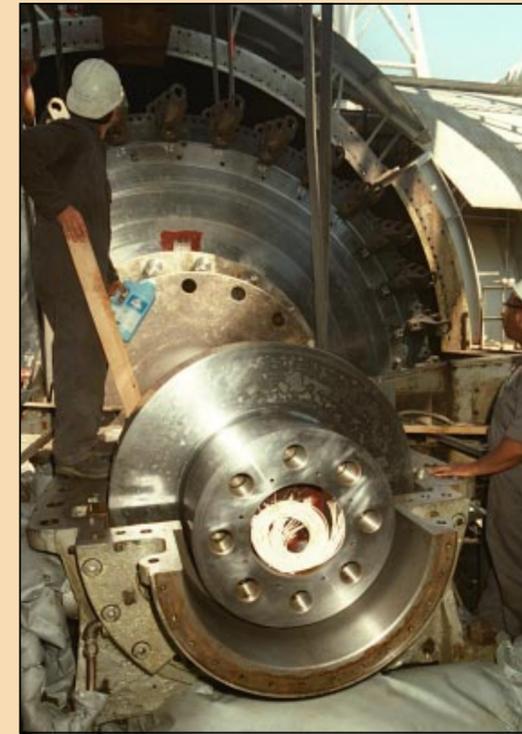
Outside machinist Brian Bergmann positions the C1 rotor as it settles into bearings while holding a jug of lubricating oil to pour over the journal bearing before final placement.
