intercoolers. Planning played a key role in the success of the intercooler upgrade. Integration and scheduling of resources had to be carefully executed in order to eliminate delays and dead-times in the schedule while keeping workers safe.

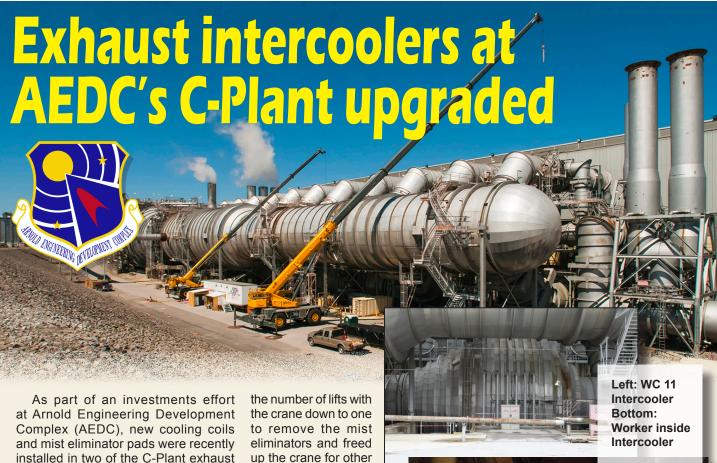
The intercoolers are large structures and each has three banks of 20 coils for a total of 60 coils. A fourth bank houses 20 frames of mist eliminator pads. Both intercoolers were upgraded concurrently to reduce plant outage, utilizing two shifts of crews working 10-hour days, six days a week.

Cost-saving measures were employed throughout the project, such as upgrading material used for flashing and drain pans to heavier gauge steel. The flashing was attached using both sheet-metal screws and bolts and a 15-degree break was introduced to secure the flashing.

protection, the coils were specified with a 1/8-inch slope per foot and service air was incorporated to blow down the coils to remove any remaining water.
